Manhole Inspection Summary

Manhole # S250O1015MH

Insp Date: **11/7/06 1:27 PM**

Location Address: **2 HILLSIDE RD**

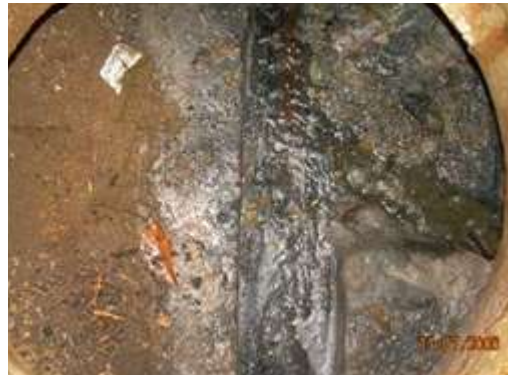
Top View

Bench and Channel debris.

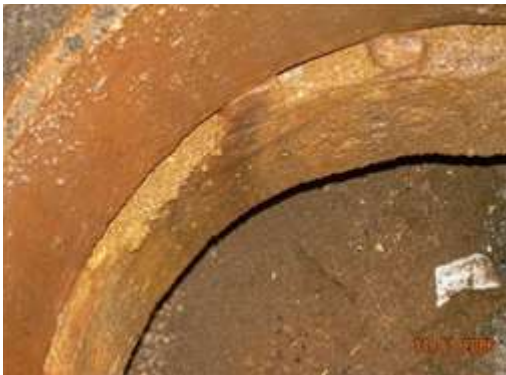
Defect

☒ **Leaks**

Infiltration: ☐ None ☒ **Joint** ☐ Cracks ☐ Mortar ☐ Roots ☐ Wall

Frame leaks. Adjustment infiltration.

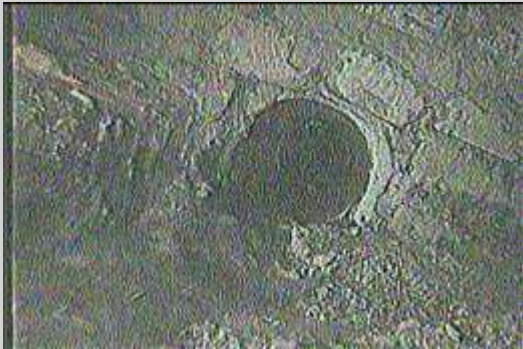
6 in. Circular Gravity Sewer Pipe Out @ 12 O'Clock

Invert Depth: **3.76** (ft.) Flow Characteristics: **Slow**

Deposits: ☐ None ☒ **Mud** ☐ Sludge ☒ **Debris** ☒ **Grease**

Silt Depth: **1** (in.) Deposits Extent: **Light**

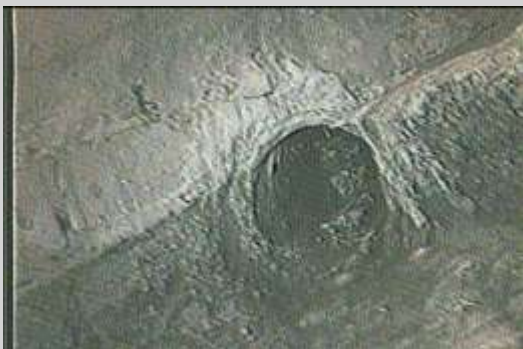
4 in. Circular Gravity Sewer Pipe In @ 3 O'Clock

Invert Depth: **3.65** (ft.) Flow Characteristics: **None**

Deposits: ☐ None ☒ **Mud** ☐ Sludge ☒ **Debris** ☒ **Grease**

Silt Depth: **1** (in.) Deposits Extent: **Light**

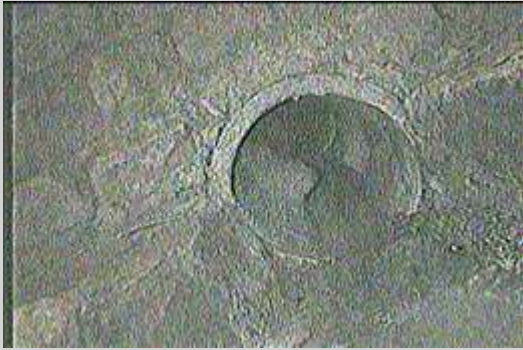
6 in. Circular Gravity Sewer

Invert Depth: **3.62** (ft.) Flow Characteristics: **Slow**

Deposits: ☒ None ☐ Mud ☐ Sludge ☐ Debris ☐ Grease
